**TRIBOLOGY AUDIT ON ISUZU TRUCK AT WORKS INFRASTRUCTURE DEPOT TAUMARUNUI
CONDUCT A TEST USING CHORNCO 2082 DIESEL FUEL CONDITIONER**

**G & M.E. Consultancy Limited
Tribology & Maintenance
11 Shoal Bay Road
Devonport
Auckland**

FEBRUARY 2003

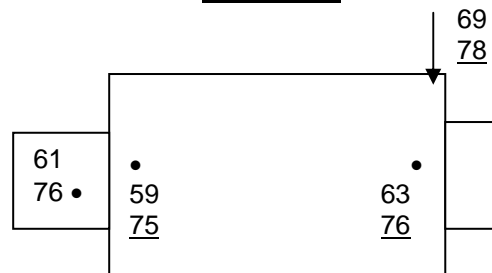
FUEL PUMP

In general comparisons between the readings taken from the injectors and the fuel pump indicated an overall reduction in the sound levels of up to 14 Db, which is significant.
